Jeffrey Mathis Inspection Service

502 Wharton St. Washington, NC

Prepared for: Dustin Jernigan

18:56 July 01, 2015

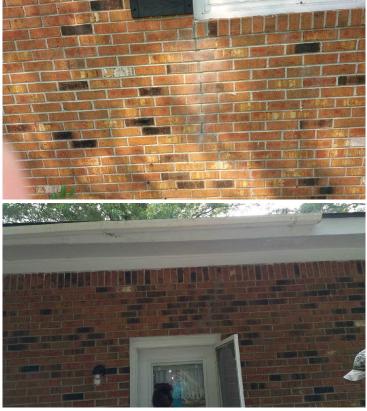
1. Marginal Type: Brick veneer - The patched cracks are in the veneer. Brick veneer is not a structural component. But if you have any concerns, they should be addressed by a licensed engineer.

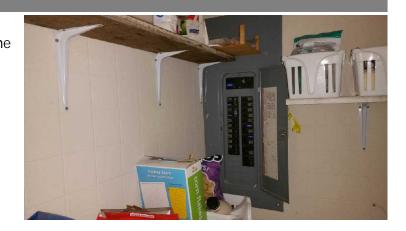
9. Marginal Manufacturer: Square D - The panel

was only partially accessible due to the shelving installed. An electrical distribution box should be fully accessible for maintenance and

examination.

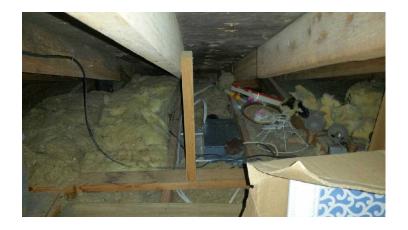
11. Marginal Bathroom Fan Venting: Ducts to the

exterior - Bathroom improperly vents

into attic and may cause moisture

damage to the insulation

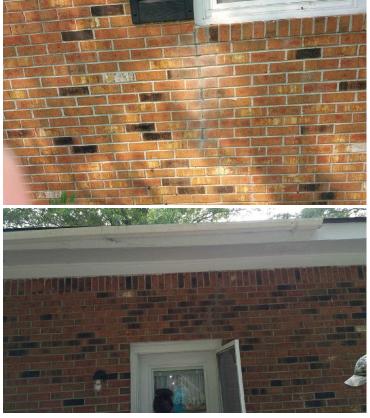
1. All Exterior Surface Type: Brick veneer - The patched cracks are in the veneer. Brick veneer is not a structural component. But if you have any concerns, they should be addressed by a licensed engineer.
